Special Consideration, when conducting PRHA inspections, on certain inspectable items that are unique to the Puerto Rico properties:

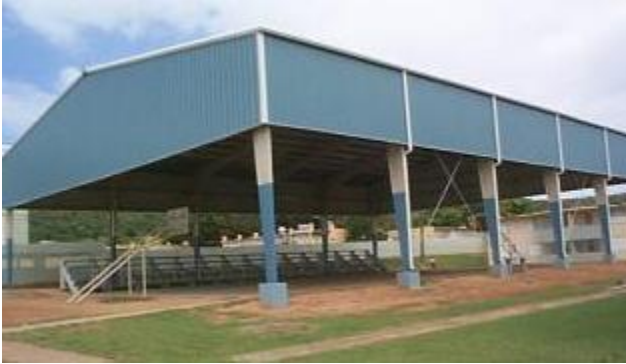
- **Building Definition:** A roof over a basketball court, with utility supported by columns and no walls is not a building under REAC definition of a building.

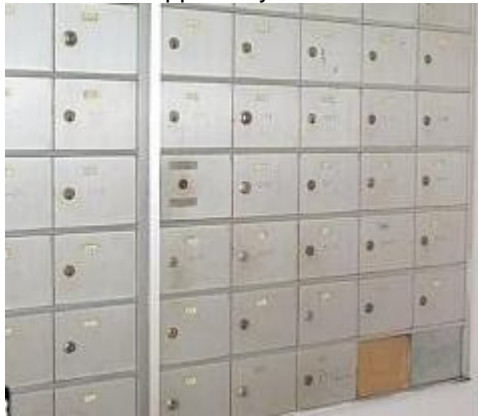
- **Mailboxes:** If the property has more mailboxes than residential units, the unused mailboxes must have doors supplied by the USPS or be enclosed by the property. There cannot be open mailboxes.

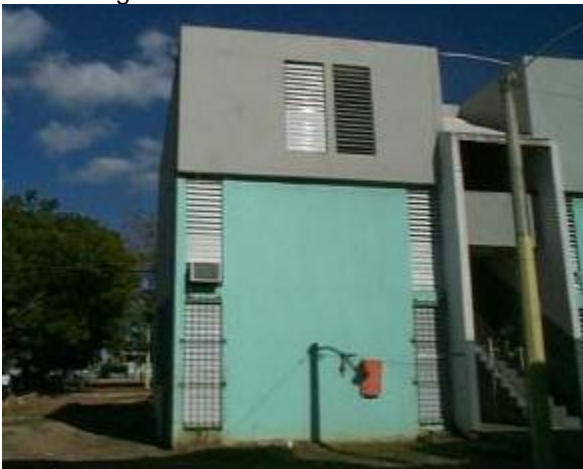
- **Windows:** Security bars on windows not intended for egress is not a defect. This also applies to blocked egress on windows that have air conditioners or furniture blocking egress from the window.

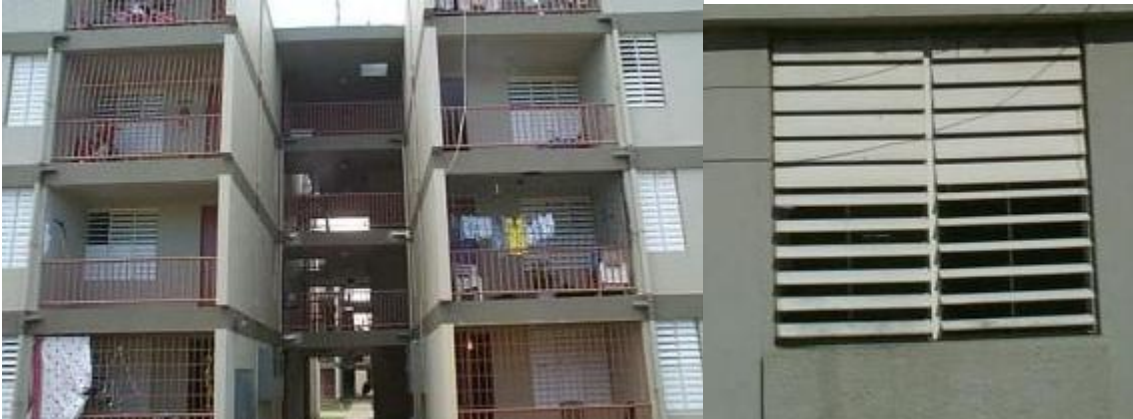
- **Windows:** Almost all PRHA's developments are installed with hurricane type window. If a jalousie window with metal panes, as found in Puerto Rico, has missing metal pane(s) or shutters, this is to be recorded as a defect under Windows/Missing Panes.

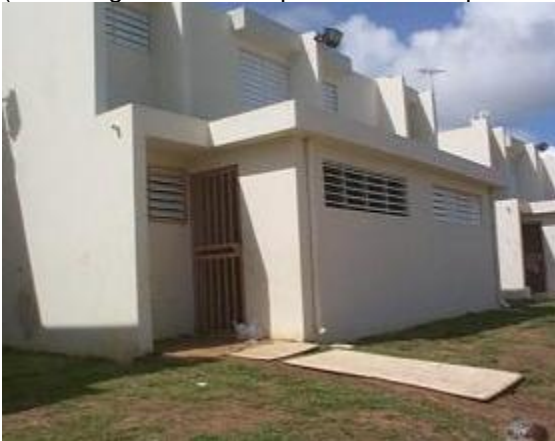
- **Porch:** If a residential unit have an extension with the porch roof or enclosed the patio with walls and a roof, these additions will be inspect under either unit if the unit is in the sample) or building exterior (if building is in the sample with no sample units).

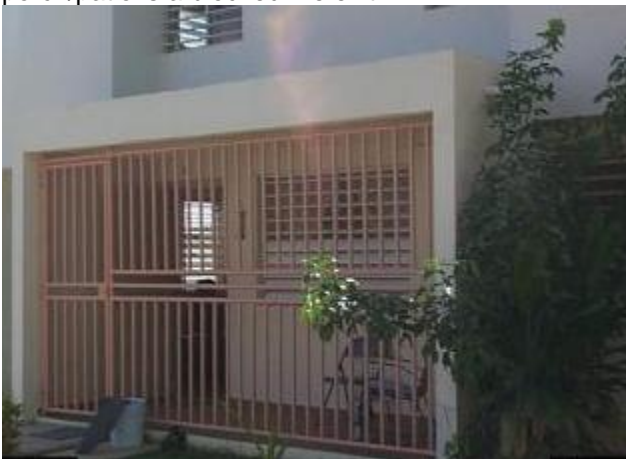
- **Blocked Egress:** A double cylinder dead bolt on a security grate that leads to an enclosed porch/patio is a blocked fire exit.

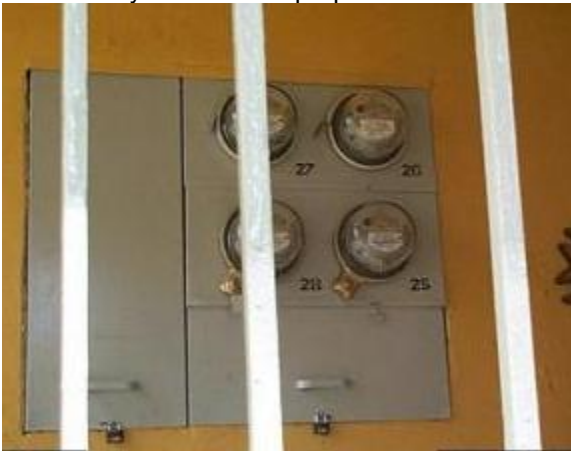
- **Blocked Electrical Panel Box:** For most of the newly constructed/modernized property in which the architectural design placed the electrical panel box servicing all units in the building on the rear wall in one of the ground floor unit. And in PR, every ground floor apartments are modernized with security bar and gate that block access to this ground floor apartment. As a result, the electrical panel box cannot be inspected unless the resident in this ground floor apartment happen to be home during the inspection. Inspectors to record blocked egress - electrical panel in every buildings in these newly constructed properties.
